Manhole Inspection Summary

Manhole # S37II_021MH

Location Address: **400 FEDERAL ST**

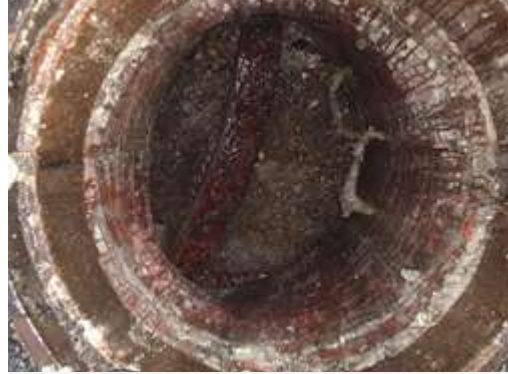
Top View

Corroded and missing steps. Evidence of surcharge - Bench debris.

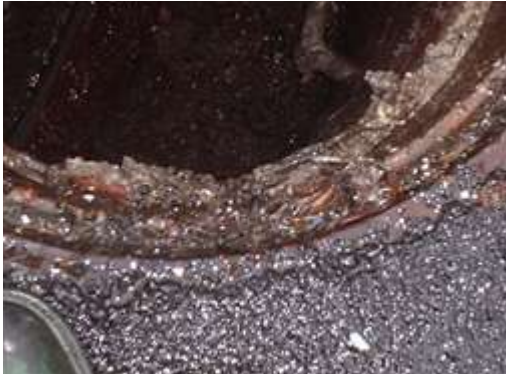
Defect

Frame leaks. Frame offset.

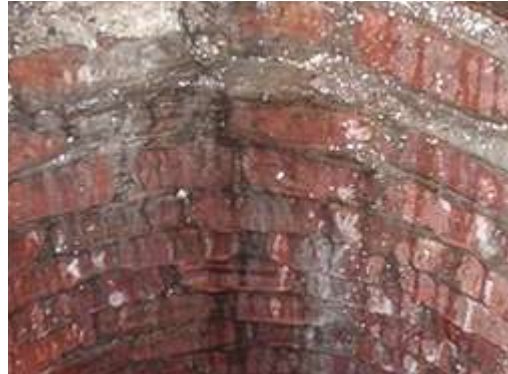
Defect

Adjustment and Corbel infiltration.

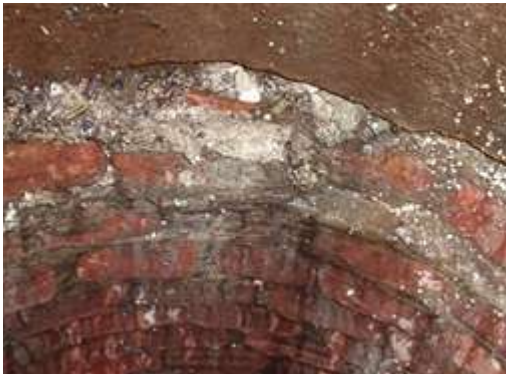
Defect

Frame leaks. Adjustment deterioration and infiltration.

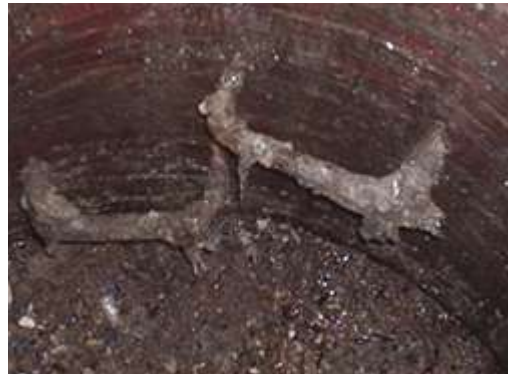
Defect

Corroded steps. Evidence of surcharge.

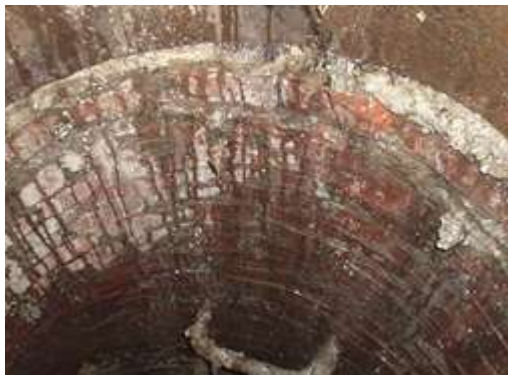
Defect

Frame leaks. Adjustment deterioration and infiltration. Barrel infiltration.
